Advanced Turbine Support

General Electric 7FA:

Dovetail cracking on the standard R-0 blades and the R-1 blades.

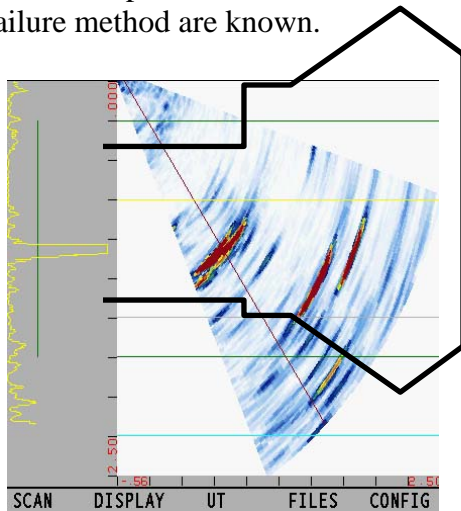
7FA Standard R-0 blade on unit 1 with a 1.8" dovetail crack.

Perform a phased array ultrasonic inspection of the R-0 and R-1 blade platforms as soon as possible. Any fretting indications found should be monitored on a 15-start interval. Normal inspection interval should not exceed 6 months until more details about the failure method are known.

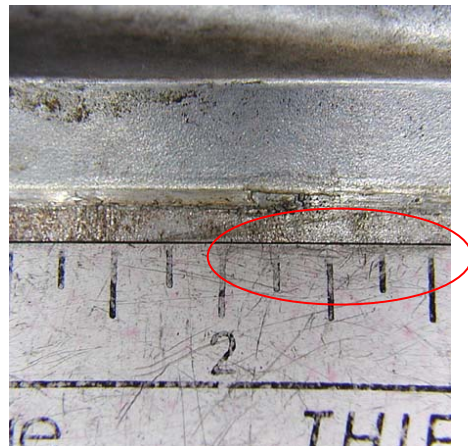
This close-up photograph shows where a crack was identified on unit 2. The crack was verified using UT in place and ET when removed. Best viewed at 200% zoom.
